# Manhole Inspection Summary

Manhole # S05WW1025MH

Insp Date: **9/13/06 7:52 AM**

**Location** Address: **5817 HIGHGATE DR**

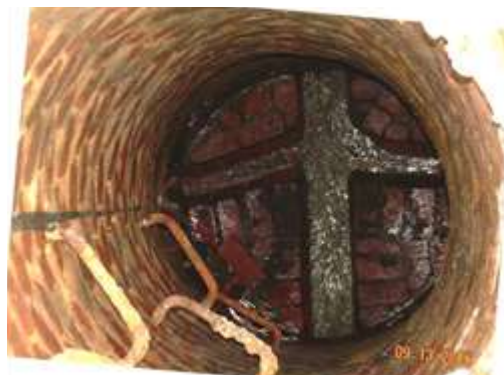
Top View

Adjustment and Corbel infiltration.  
Corroded steps. Bench debris.

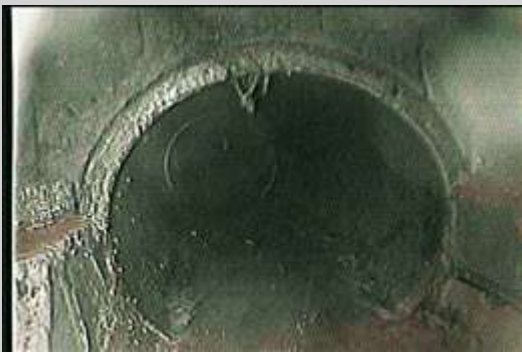
### 10 in. Circular Gravity Sewer Pipe Out @ 12 O'Clock

Infiltration: **None** Pipe Seal Cond: **Roots**

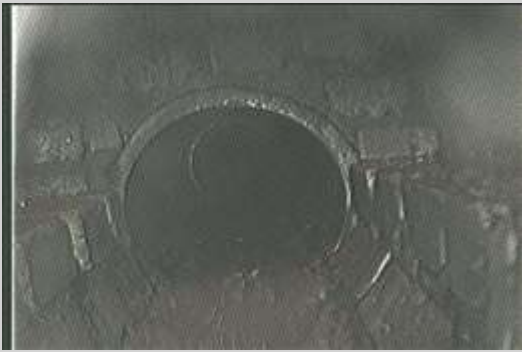
### 10 in. Circular Gravity Sewer

Channel deterioration.

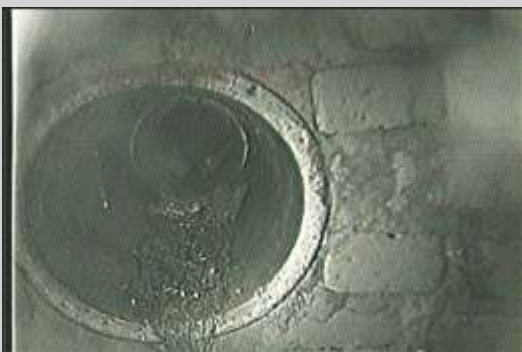
### 8 in. Circular Gravity Sewer

Deposits: ☐ None ☒ **Mud** ☐ Sludge ☒ **Debris** ☐ Grease

Silt Depth: **0** (in.) Deposits Extent: **Light**

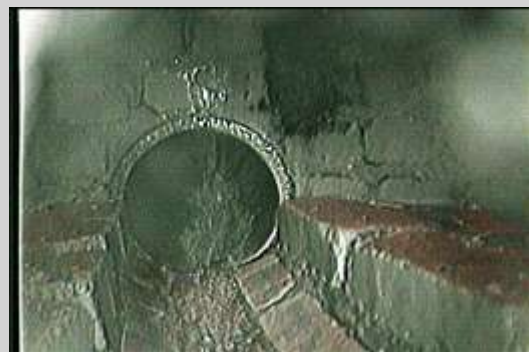
Drop In @ 9 O'Clock

Drop Condition: **Partly Clogged**
